**Flood Control Project Maintenance
Levee Inspections**
LMA District Cover Sheet
Spring 2017 Levee Inspection Results

Plumas County

Levee Inspection Report By Mile - Spring 2017

Waterway	Bank	Unit Miles	Inspection Start/End	Inspector
Unit No. 01 North Fork Feather River	Left	1.89	04/27/2017 04/27/2017	Bob Duffey

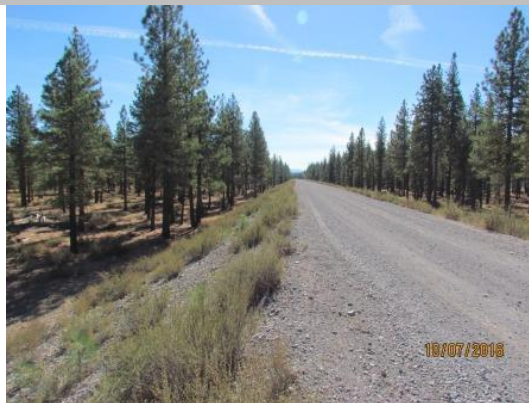
Photo 1 of 1 : SP_2017_NA0015_337_11_20170315_00008.jpg

LM Start	0.00	Rating **	M	Issue No.	11
LM End	1.89	Issue Type +	Ma	Location *	LS
Category	Earthen Levee			GPS Latitude/Longitude	
				Start	End
Item	Vegetation			40.273168 °	40.297283 °
				-121.244783 °	-121.257025 °
DWR ID	DWR_NA0015_01_f_2015_11				
Comment Code					
V2 : Remove the wild growth other than native grasses from the levee slopes.					
Inspector Comment					
Remove the small pine trees and other vegetation from the levee slope.

View of the small pine trees and other vegetation on the slope.

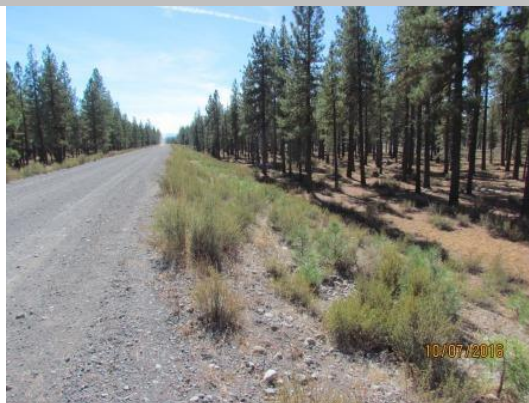
Photo 1 of 1 : SP_2017_NA0015_337_12_20170315_00009.jpg

LM Start	0.00	Rating **	M	Issue No.	12
LM End	1.89	Issue Type +	Ma	Location *	WS
Category	Earthen Levee			GPS Latitude/Longitude	
				Start	End
Item	Vegetation			40.273168 °	40.297283 °
				-121.244783 °	-121.257025 °
DWR ID	DWR_NA0015_01_f_2015_12				
Comment Code					
V2 : Remove the wild growth other than native grasses from the levee slopes.					
Inspector Comment					
Remove all small pine trees and other vegetation from the levee slope.

View of the small pine trees and other vegetation on the slope.

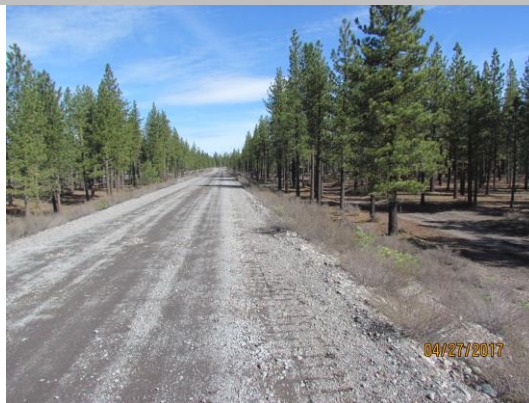
Photo 1 of 1 : SP_2017_NA0015_337_14_20170505_00015.jpg

LM Start	0.12	Rating **	M	Issue No.	14
LM End	0.12	Issue Type +	Ma	Location *	LS
Category	Earthen Levee			GPS Latitude/Longitude	
				Start	End
Item	Vegetation			40.274660 °	40.274660 °
				-121.245638 °	-121.245638 °
DWR ID	DWR_NA0015_01_s_2017_14				
Comment Code					
V2 : Remove the wild growth other than native grasses from the levee slopes.					
Inspector Comment					
Remove the small pine trees from the landside slope.

View of the small pine trees along the landside slope.

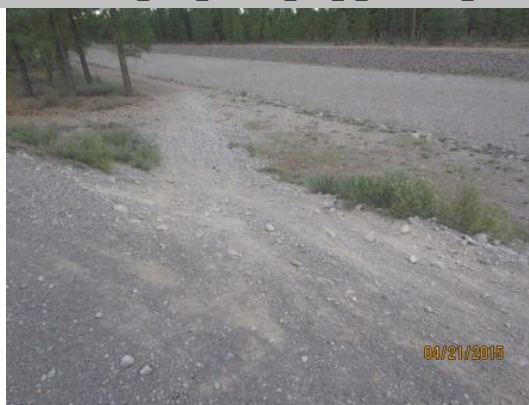
Photo 1 of 1 : SP_2017_NA0015_337_9_20170315_00007.jpg

LM Start	0.55	Rating **	M	Issue No.	9
LM End	0.55	Issue Type +	Ma	Location *	WS
Category	Earthen Levee			GPS Latitude/Longitude	
				Start	End
Item	Slope Stability			40.279790 °	121.249850 °
				40.279790 °	121.249850 °
DWR ID	DWR_NA0015_01_s_2012_9				
Comment Code					
S3 : Repair the levee slope damaged by vehicle traffic and prevent access where possible.					
Inspector Comment

View of the vehicle erosion along the waterside toe.

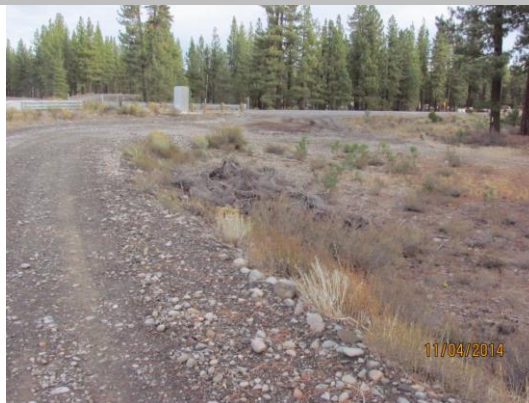
Photo 1 of 1 : SP_2017_NA0015_337_4_20170315_00001.jpg

LM Start	0.68	Rating **	M	Issue No.	4
LM End	0.68	Issue Type +	Ma	Location *	LS
Category	Earthen Levee			GPS Latitude/Longitude	
				Start	End
Item	Encroachments			40.281480 °	40.281480 °
				-121.250928 °	-121.250928 °
DWR ID	DWR_NA0015_01_s_2013_4				
Comment Code					
PR : Prunings					
Inspector Comment

View of the prunings along the landside slope.

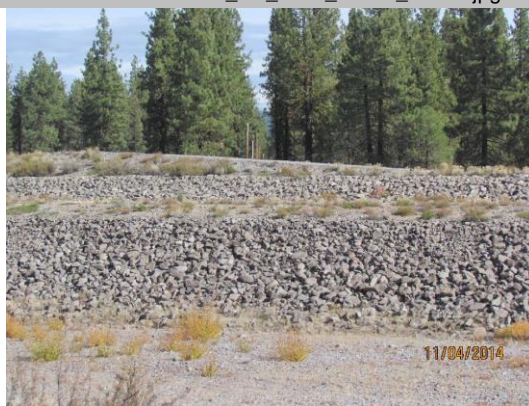
Photo 3 of 3 : UCIP_SP_2017_42643_72982.jpg

LM Start	0.77	Rating **	M	Issue No.	17 (cont)
LM End	0.77	Issue Type +	En	Location *	LS
Category	Supplemental			GPS Latitude/Longitude	
				Start	End
Item	DWR UCIP Field Study			40.282683 °	40.282683 °
				-121.251453 °	-121.251453 °
DWR ID					
Comment Code					
Inspector Comment					
FS_ID:42643 DS_ID:23039 EP_NO: N/A Repair Type: Non-Urgent Crossing Status: Indicator Found UCIP Comments: Need to contact owner to determine additional information about crossing. Need depth of conduit and permit issued. FIELD_STRUCT_DESC: Underground telephone cable through the levee and across the channel. Elevation unknown. FS Date: 11/4/2014

View of levee, ramp, and posts visible between trees.

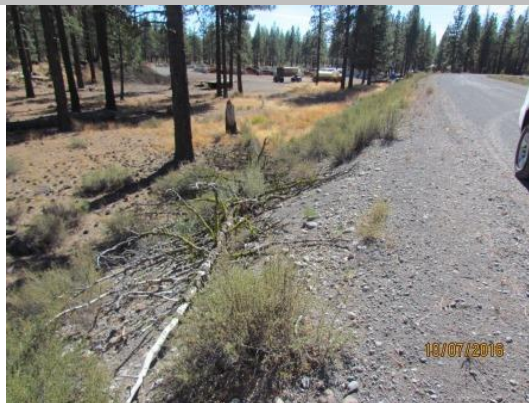
Photo 1 of 1 : SP_2017_NA0015_337_13_20170315_00010.jpg

LM Start	0.88	Rating **	M	Issue No.	13
LM End	0.88	Issue Type +	En	Location *	LS
Category	Earthen Levee			GPS Latitude/Longitude	
				Start	End
Item	Encroachments			40.284309 °	40.284309 °
				-121.251541 °	-121.251541 °
DWR ID	DWR_NA0015_01_f_2016_13				
Comment Code					
TR : Tree or limb					
Inspector Comment					
Remove the fallen tree from the levee slope.

View of the fallen tree on the landside slope.

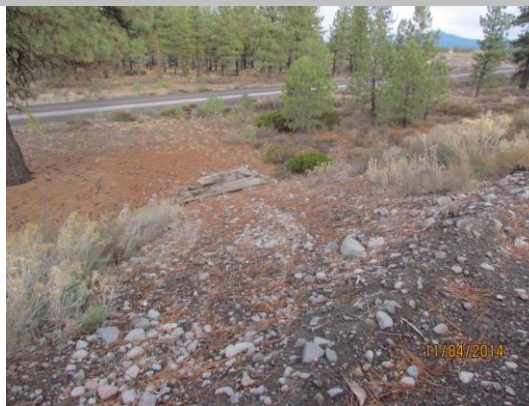
Photo 1 of 1 : SP_2017_NA0015_337_5_20170315_00002.jpg

LM Start	0.96	Rating **	A/W	Issue No.	5
LM End	0.96	Issue Type +	Ma	Location *	WS
Category	Earthen Levee			GPS Latitude/Longitude	
				Start	End
Item	Slope Stability			40.285363 °	40.285363 °
				-121.251973 °	-121.251973 °
DWR ID	DWR_NA0015_01_f_2013_5				
Comment Code					
S3 : Repair the levee slope damaged by vehicle traffic and prevent access where possible.					
Inspector Comment

View of the vehicle erosion along the waterside slope.

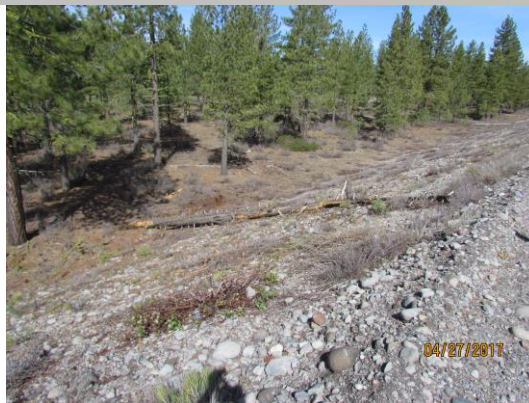
Photo 1 of 1 : SP_2017_NA0015_337_16_20170505_00017.jpg

LM Start	1.17	Rating **	M	Issue No.	16
LM End	1.17	Issue Type +	En	Location *	WS
Category	Earthen Levee			GPS Latitude/Longitude	
				Start	End
Item	Encroachments			40.287722 °	40.287722 °
				-121.253510 °	-121.253510 °
DWR ID	DWR_NA0015_01_s_2017_16				
Comment Code					
TR : Tree or limb					
Inspector Comment					
Remove the tree from the landside slope and toe.

View of the tree along the landside slope and toe.

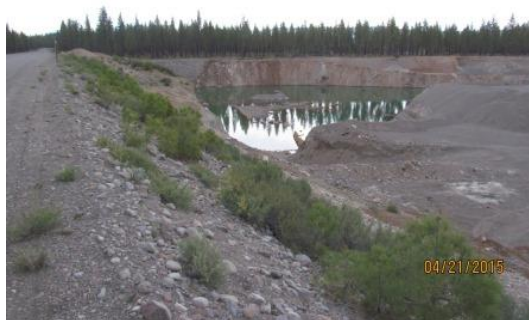
Photo 1 of 2 : SP_2017_NA0015_337_7_20170315_00004.jpg

LM Start	1.41	Rating **	U	Issue No.	7
LM End	1.50	Issue Type +	Ma	Location *	LS
Category	Earthen Levee			GPS Latitude/Longitude	
				Start	End
Item	Slope Stability			40.290758 °	40.291987 °
				-121.255402 °	-121.256072 °
DWR ID	DWR_NA0015_01_f_2014_7				
Comment Code					
S1 : Repair slope instability.					
Inspector Comment					
The landowner needs to replace the material that has been removed from the toe of the levee.

View of the area where the contractor has removed the material from toe of the levee.

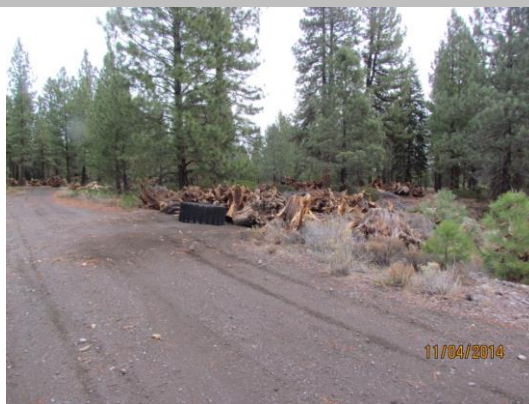
Photo 1 of 1 : SP_2017_NA0015_337_8_20170315_00006.jpg

LM Start	1.86	Rating **	M	Issue No.	8
LM End	1.86	Issue Type +	En	Location *	LS
Category	Earthen Levee			GPS Latitude/Longitude	
				Start	End
Item	Encroachments			40.296910 °	40.296910 °
				-121.257280 °	-121.257280 °
DWR ID	DWR_NA0015_01_f_2014_8				
Comment Code					
TR : Tree or limb					
Inspector Comment					
Remove the tree stumps from the slope of the levee.

View of the tree stumps at the levee slope.

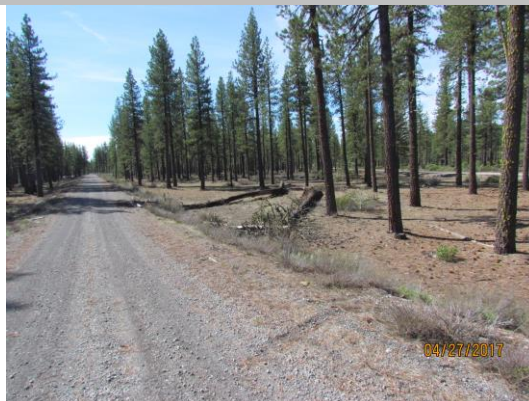
Photo 1 of 2 : SP_2017_NA0015_338_9_20170505_00012.jpg

LM Start	0.31	Rating **	M	Issue No.	9
LM End	0.31	Issue Type +	En	Location *	LS
Category	Earthen Levee			GPS Latitude/Longitude	
				Start	End
Item	Encroachments			40.284993 °	40.284993 °
				-121.255133 °	-121.255133 °
DWR ID	DWR_NA0015_02_s_2015_9				
Comment Code					
TR : Tree or limb					
Inspector Comment					
Remove the pine trees from the landside slope.

View of the pine trees that has fallen onto the landside slope.

View of the pine tree that has fallen onto the landside slope.

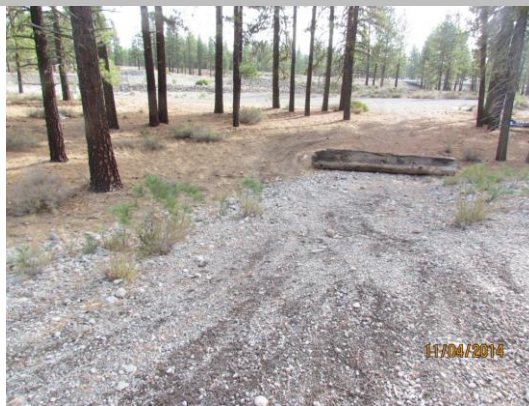
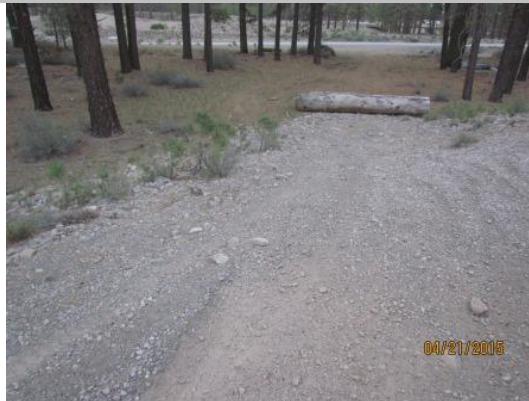
Photo 1 of 2 : SP_2017_NA0015_338_6_20170315_00005.jpg

LM Start	0.46	Rating **	M	Issue No.	6
LM End	0.46	Issue Type +	Ma	Location *	WS
Category	Earthen Levee			GPS Latitude/Longitude	
				Start	End
Item	Slope Stability			40.283059 °	40.283059 °
				-121.253989 °	-121.253989 °
DWR ID	DWR_NA0015_02_f_2013_6				
Comment Code					
S3 : Repair the levee slope damaged by vehicle traffic and prevent access where possible.					
Inspector Comment

View of the vehicle erosion on the landside slope.

View of the vehicle erosion on the waterside slope.

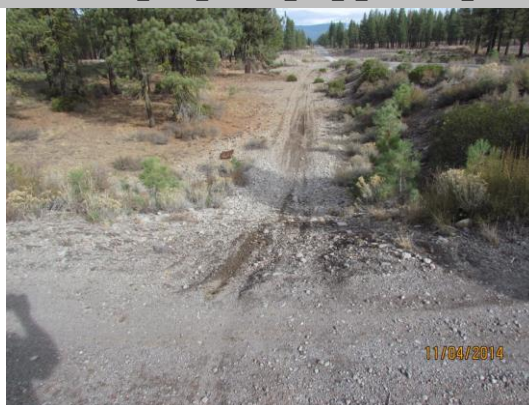
Photo 1 of 1 : SP_2017_NA0015_338_5_20170315_00004.jpg

LM Start	0.55	Rating **	M	Issue No.	5
LM End	0.55	Issue Type +	Ma	Location *	WS
Category	Earthen Levee			GPS Latitude/Longitude	
				Start	End
Item	Slope Stability			40.281950 °	121.253710 °
				40.281950 °	121.253710 °
DWR ID	DWR_NA0015_02_s_2012_5				
Comment Code					
S3 : Repair the levee slope damaged by vehicle traffic and prevent access where possible.					
Inspector Comment

View of the vehicle erosion on the waterside slope.

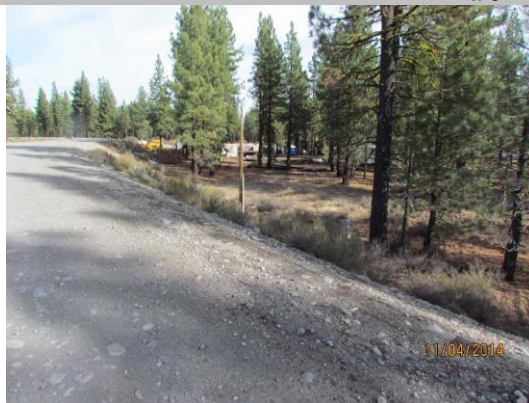
Photo 1 of 3 : UCIP_SP_2017_42644_72984.jpg

LM Start	0.66	Rating **	M	Issue No.	11
LM End	0.66	Issue Type +	En	Location *	WS
Category	Supplemental			GPS Latitude/Longitude	
				Start	End
Item	DWR UCIP Field Study			40.280737 °	40.280737 °
				-121.252512 °	-121.252512 °
DWR ID					
Comment Code					
Inspector Comment					
FS_ID:42644					
DS_ID:23040					
EP_NO: N/A					
Repair Type: Non-Urgent					
Crossing Status: Indicator Found					
UCIP Comments: Need to contact owner to determine additional information about crossing. Need depth of conduit and permit issued.					
FIELD_STRUCT_DESC: Underground telephone cable through the levee and across the channel. Elevation unknown.					
FS Date: 11/4/2014

View of landward side conduit pole located at landward toe. Photo taken from the left bank.

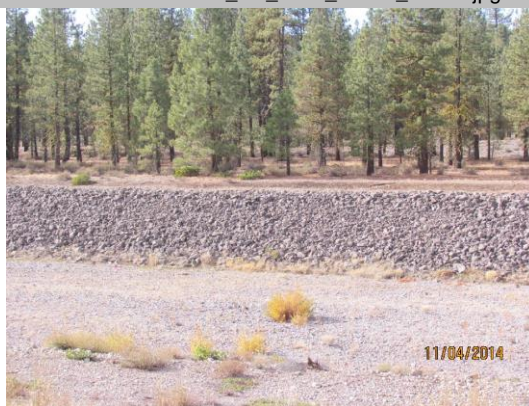
Photo 3 of 3 : UCIP_SP_2017_42644_72985.jpg

LM Start	0.66	Rating **	M	Issue No.	11 (cont)
LM End	0.66	Issue Type +	En	Location *	WS
Category	Supplemental			GPS Latitude/Longitude	
				Start	End
Item	DWR UCIP Field Study			40.280737 °	40.280737 °
				-121.252512 °	-121.252512 °
DWR ID					
Comment Code					
Inspector Comment					
FS_ID:42644 DS_ID:23040 EP_NO: N/A Repair Type: Non-Urgent Crossing Status: Indicator Found UCIP Comments: Need to contact owner to determine additional information about crossing. Need depth of conduit and permit issued. FIELD_STRUCT_DESC: Underground telephone cable through the levee and across the channel. Elevation unknown. FS Date: 11/4/2014

View of opposite bank.

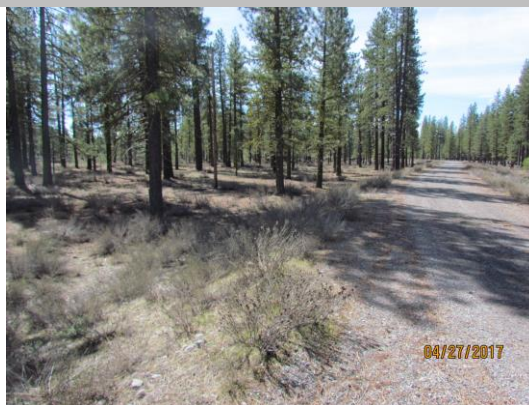
Photo 1 of 1 : SP_2017_NA0015_338_10_20170505_00013.jpg

LM Start	0.72	Rating **	M	Issue No.	10
LM End	1.36	Issue Type +	Ma	Location *	WS
Category	Earthen Levee			GPS Latitude/Longitude	
				Start	End
Item	Vegetation			40.279897 °	40.271772 °
				-121.252123 °	-121.246785 °
DWR ID	DWR_NA0015_02_s_2017_10				
Comment Code					
V2 : Remove the wild growth other than native grasses from the levee slopes.					
Inspector Comment					
Remove the vegetation from the waterside slope.

View of the vegetation along the water side slope.
